# **MID -AIR COLLISION BETWEEN AN ASK 21 AND AN ASK 13 NEAR LASHAM ON 5 AUGUST 2011**

## Preliminary Information

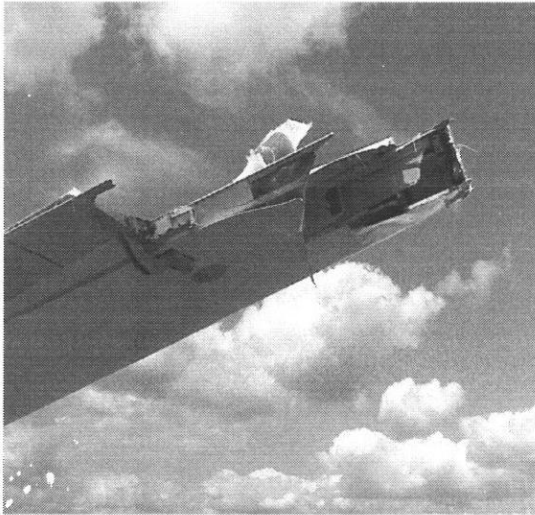
ASK 13

The K13, a Lasham based glider, lost approximately the outer 5 feet of its right wing, which included the outer half of the aileron, outboard of the drive rod/mass balance weight. This was located the following day in a small wood at the western end of the main runway. The K21, a Booker based glider, sustained relatively localised crushing damage to the leading edge of the right wing ahead of the airbrake box, with additional damage to the spar and shear web in this area, see below.
